**National Pollutant Discharge Elimination System
(NPDES)
Inspection Report**

**P4 Production, LLC – Processing Facility
(a subsidiary of the Monsanto Company)
Soda Springs, Idaho**

NPDES Permit # ID0001198

**Inspection date: September 17, 2013
Report completion date: November 20, 2013**

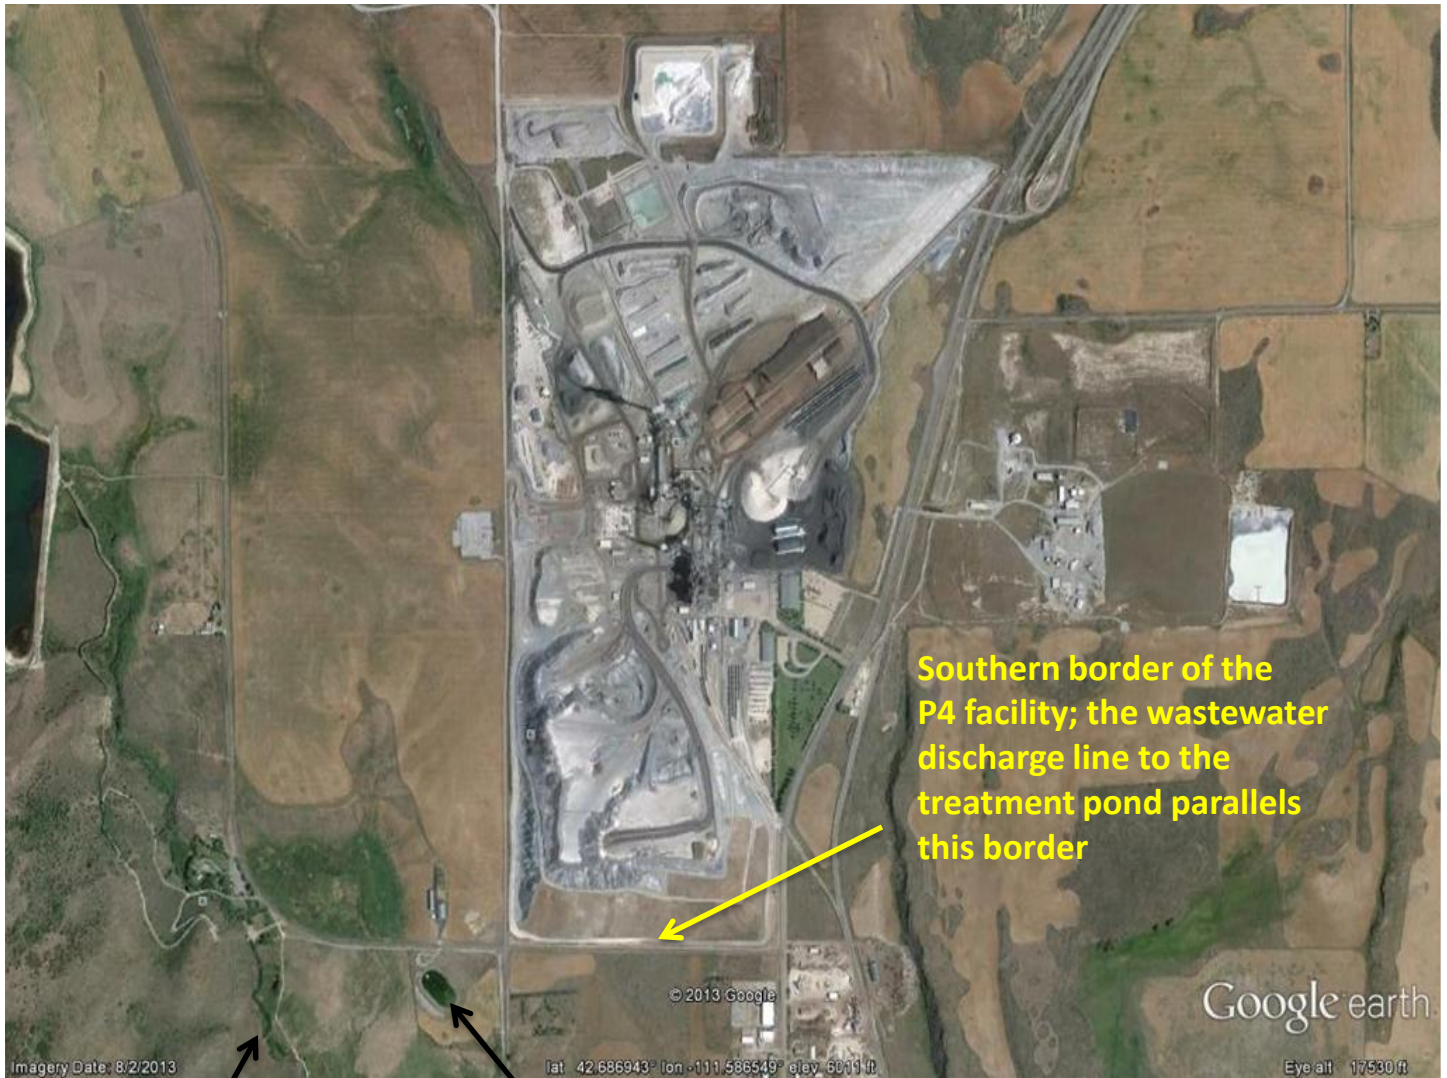
**Discharge location
to Soda Creek**

Wastewater Treatment Pond

Photo No. 2 – from Google Earth Pro (imagery date 08/12/2013)
Overview of the entire P4 Production and wastewater management operations

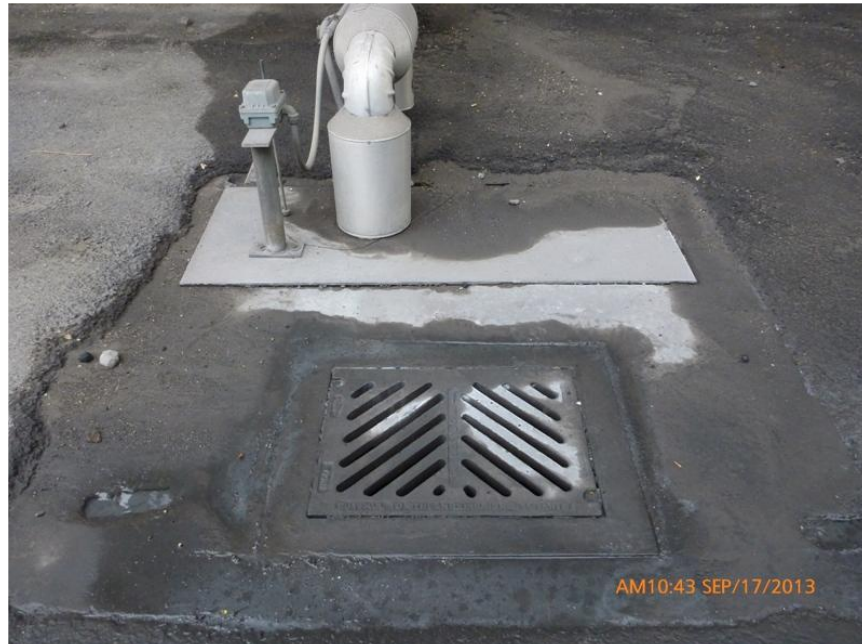
Photo No. 3 (P1000170)
An example of the numerous storm drains located throughout the production facility

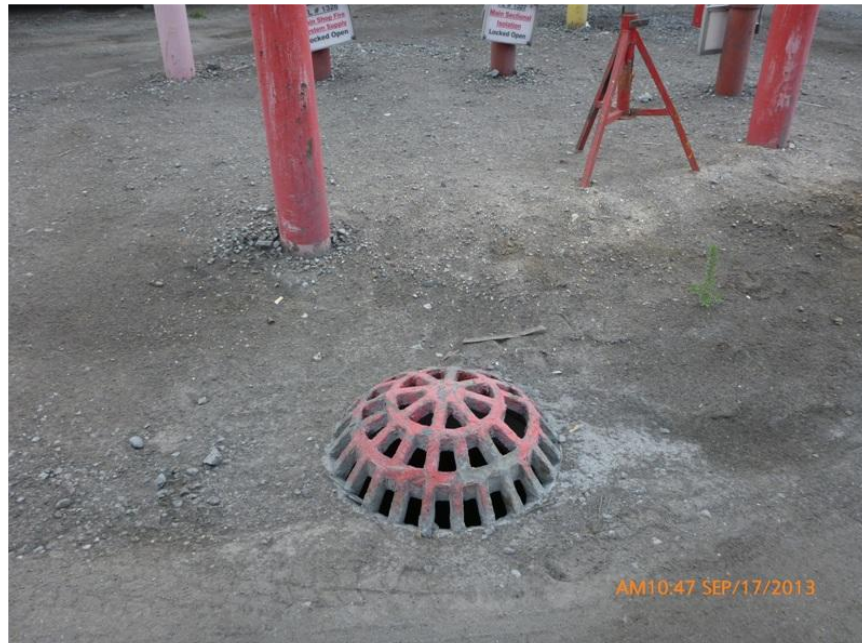
Photo No. 4 (P1000171)
An example of the numerous storm drains located throughout the production facility

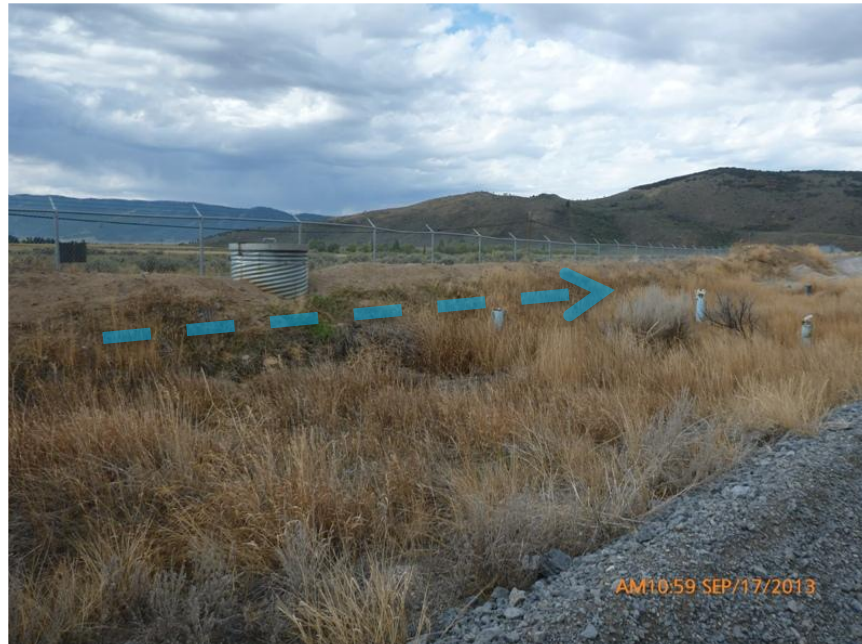
Photo No. 5 (P1000173)

A large culvert, shallowly buried along the southern border of the facility, conveys wastewater to the wastewater treatment pond. The vertical culvert is capped with an access manhole cover.

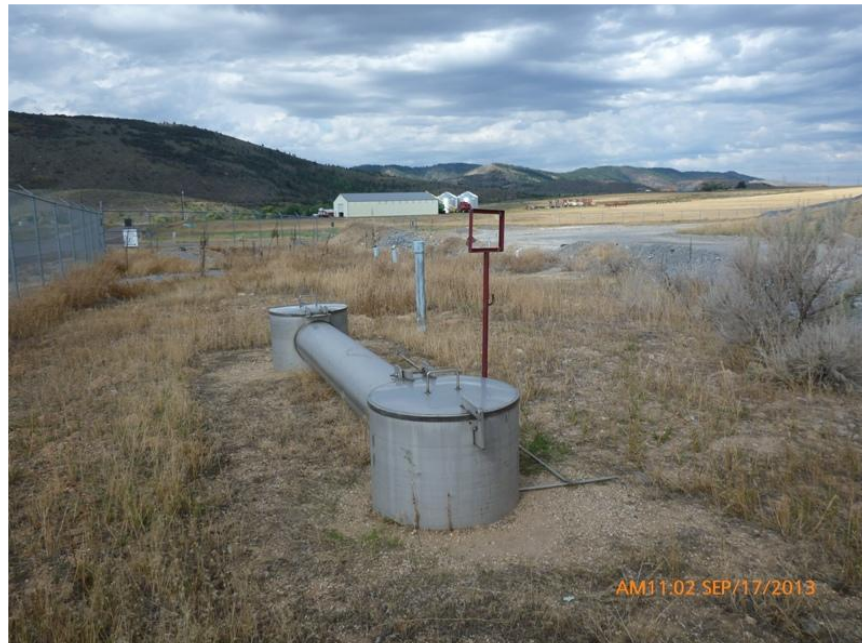
Photo No. 6 (P1000174)

Wastewater flows through this oil-water separator located in the SW corner of the facility property on its way to the treatment pond; monitoring wells (light blue) associated with on-site CERCLA activities are also evident in this photo.

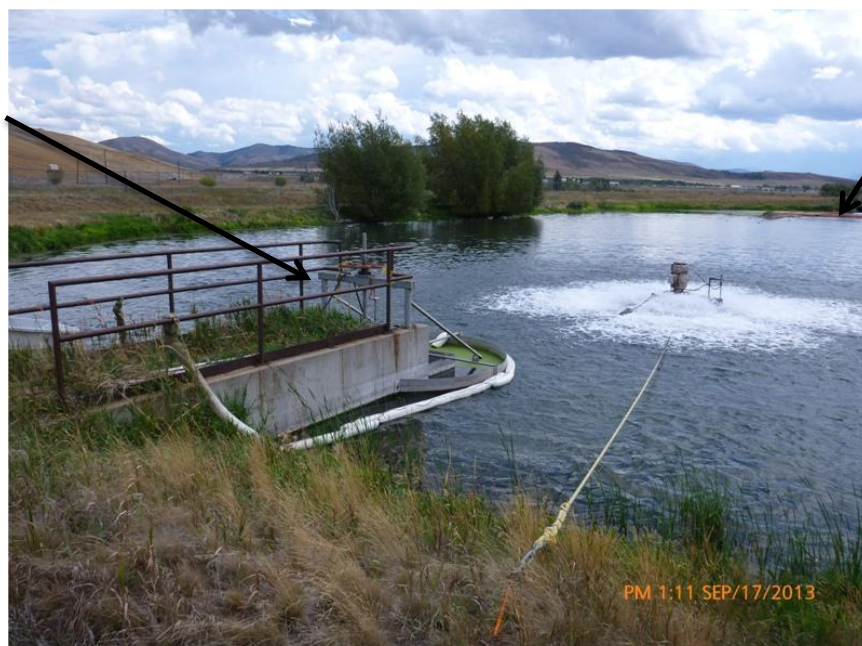
Outlet from
pond at
NW corner

Inlet to
pond at
SE corner

Photo No. 7 (P1000178)
The wastewater treatment pond at P4 Production, LLC
with aerator operating within the pond

Comingled wastewater from the three sources noted above is piped to a wastewater treatment pond (see Photos 3, 7, and 8) prior to discharge to Soda Creek. The pond is located approximately 1365' from the fenced southwest corner of the active portion of the facility. The capacity of the pond is approximately 335,000 cubic feet/2.5 M gallons. The treatment taking place within the pond is primarily physical in nature; some settling of solids occurs along with aeration and cooling.

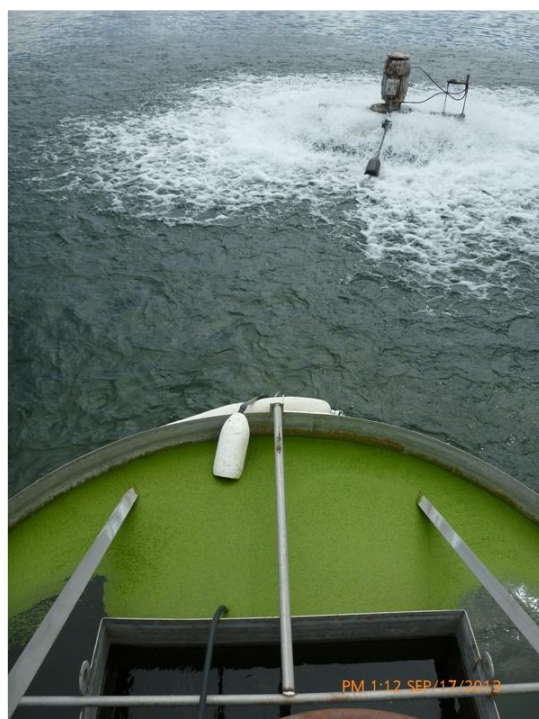
Photo No. 8 (P1000179)
Algae growth at outlet from the wastewater treatment pond

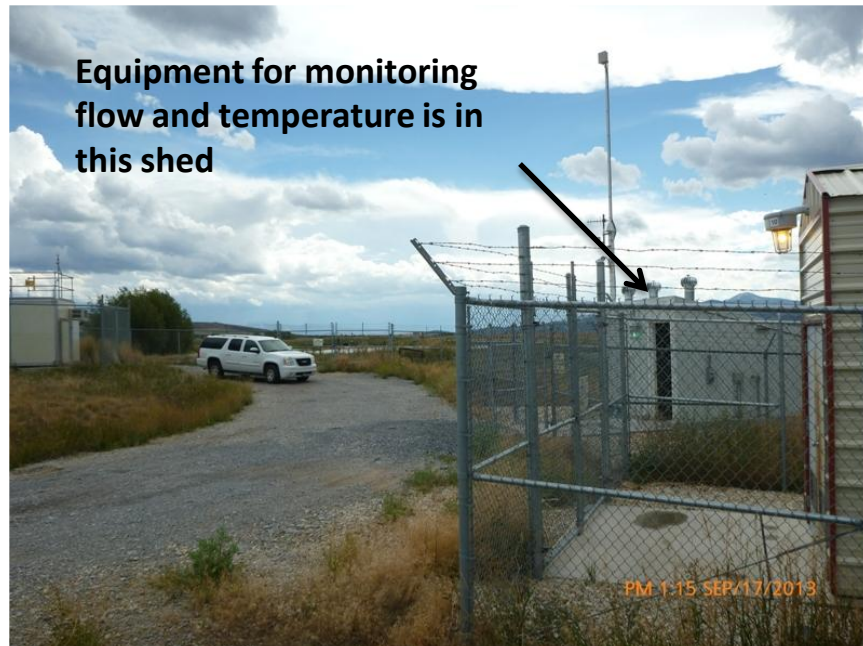
Photo No. 9 (P1000181)
Equipment sheds are located on the west side of the wastewater treatment pond.

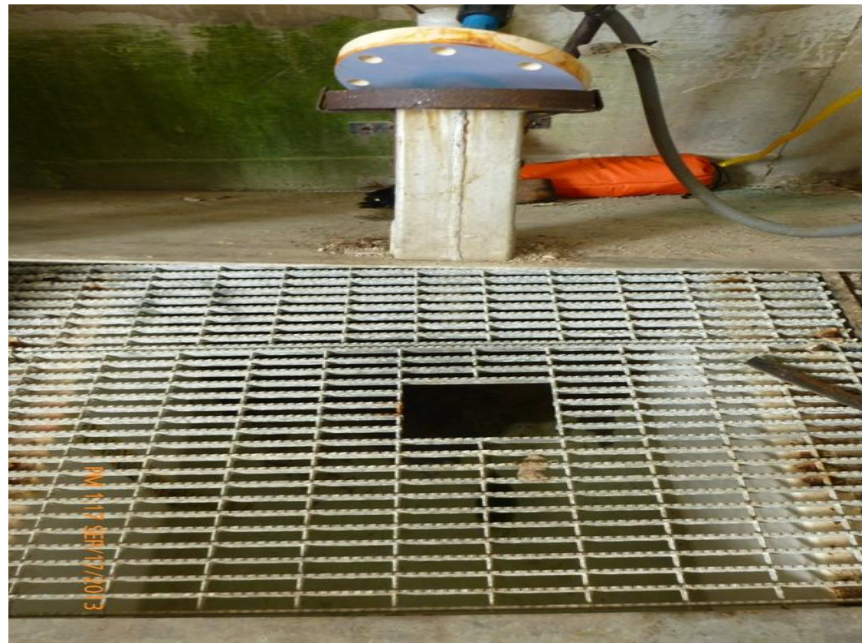
Photo No. 10 (P1000182)
A grate covers the Parshall flume used for measuring flow from the wastewater treatment pond to the discharge location at Soda Creek. The ultrasonic transducer appears at the top of the photo.
A vertical water depth indicator is also mounted on the inside wall of the flume.

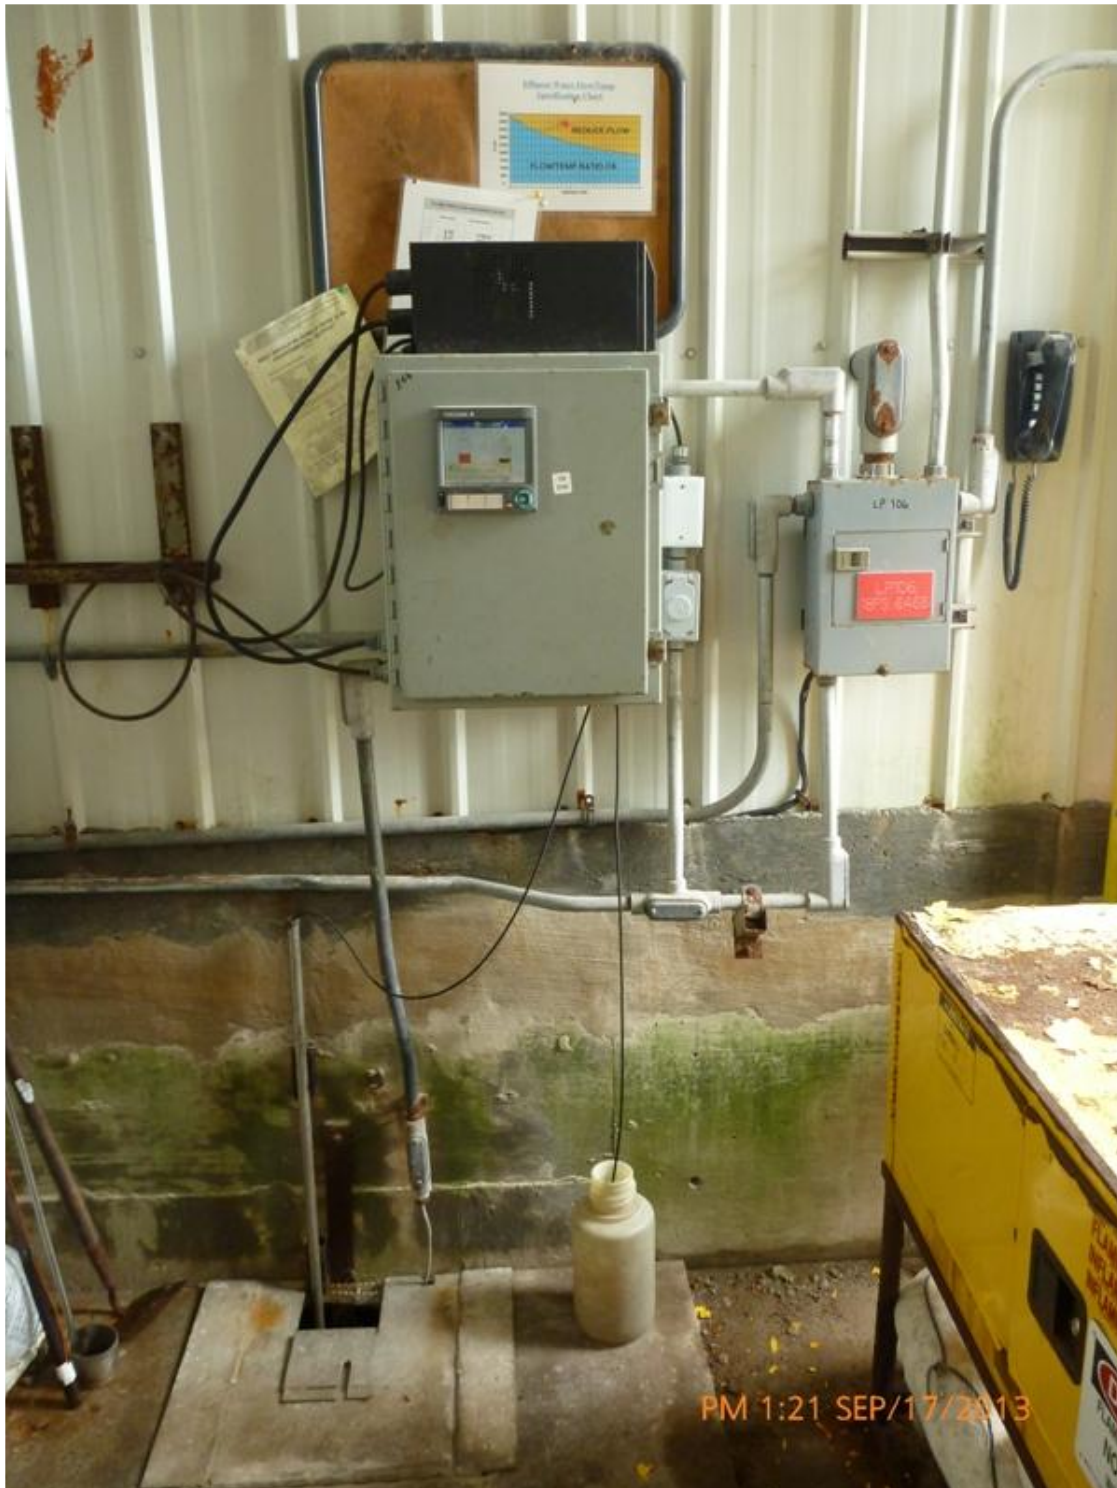
Photo No. 11 (P1000186)
Data recorder for wastewater flow rate and temperature

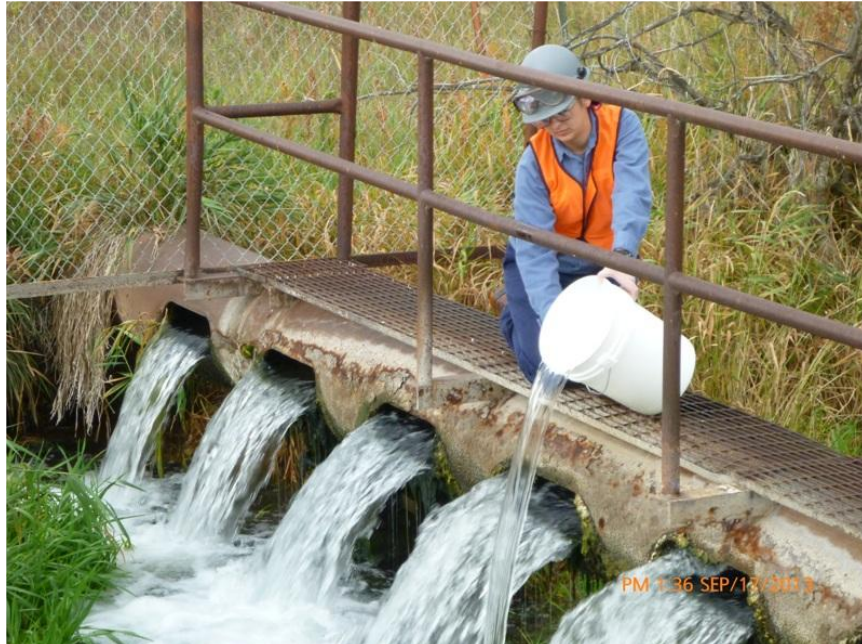
Photo No. 16 (P1000190)

P4 Production environmental engineer Molly Prickett triple-rinses the new HDPE bucket that was used to collect a single grab sample of the P4 discharge to Soda Creek.

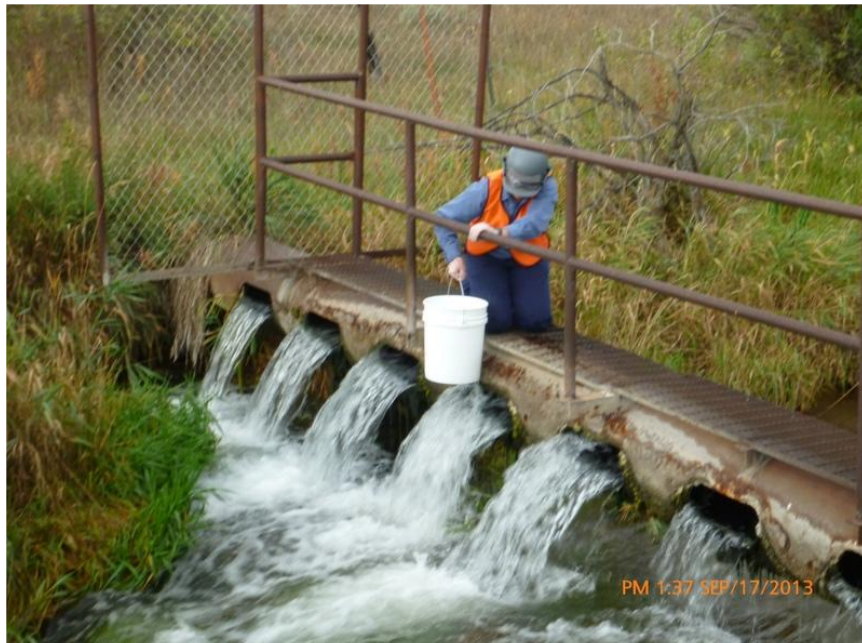
Photo No. 17 (P1000191)

P4 Production environmental engineer Molly Prickett collects a single grab sample of the P4 discharge to Soda Creek.

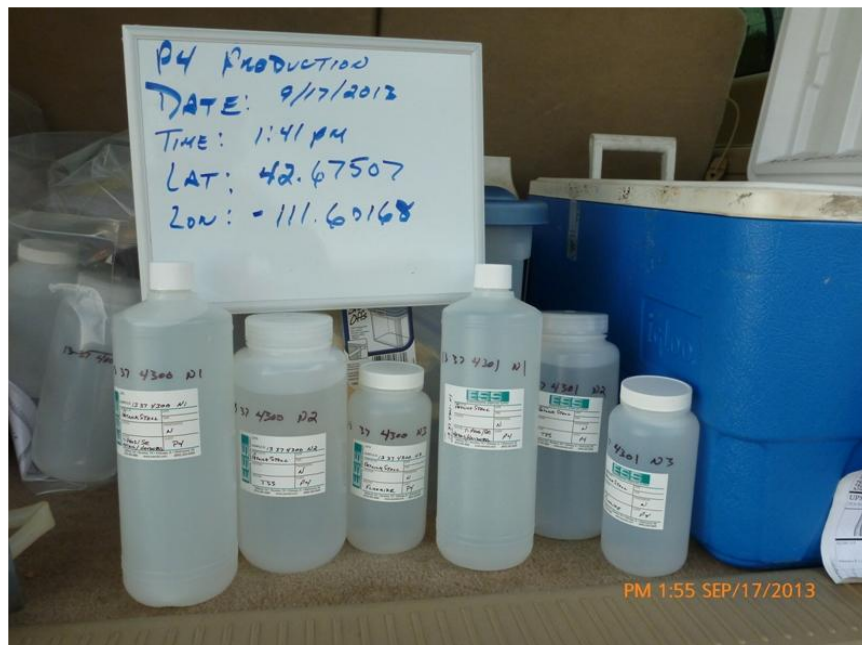
Photo No. 18 (P1000193)

Two sets of samples were collected from the single grab sample (original and a duplicate) collected at the discharge location.

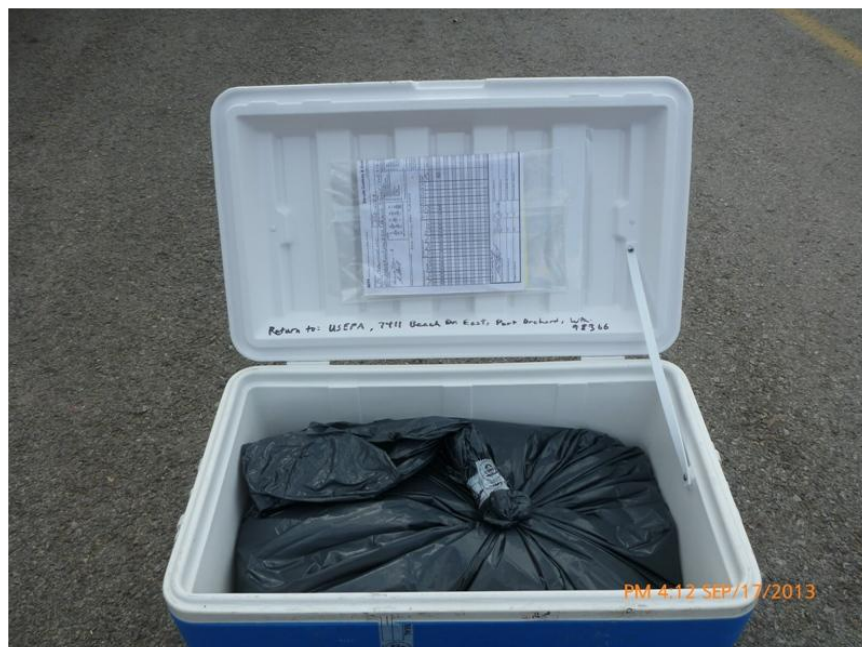
Photo No. 19 (P1000196)

Samples were packaged with ice, sealed with evidence tape, and placed in a cooler for shipment to the MEL lab; the Chain of Custody form was placed in a plastic bag affixed to the inside of cooler lid.

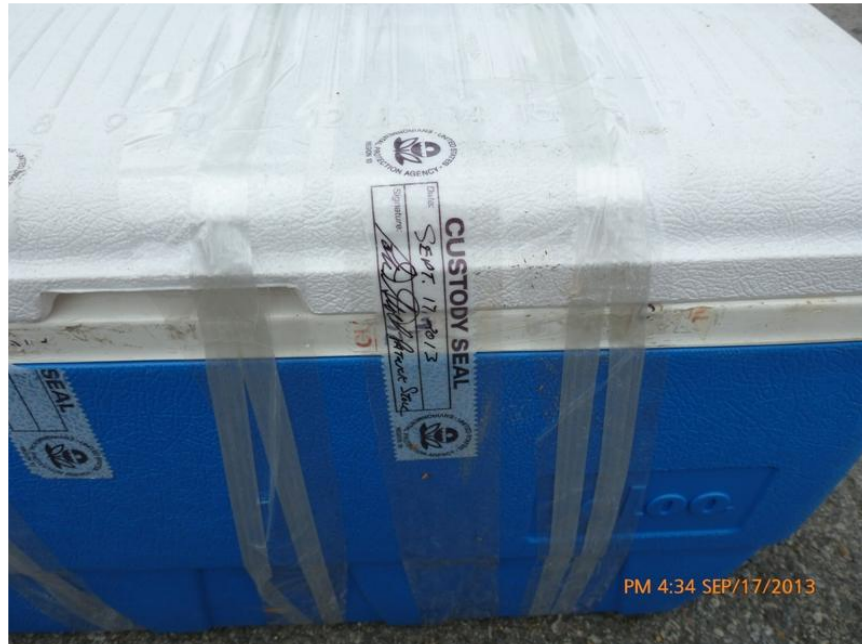
Photo No. 20 (P1000198)

The cooler with samples was sealed with strapping and evidence tape (Custody Seal) prior to delivery to UPS.

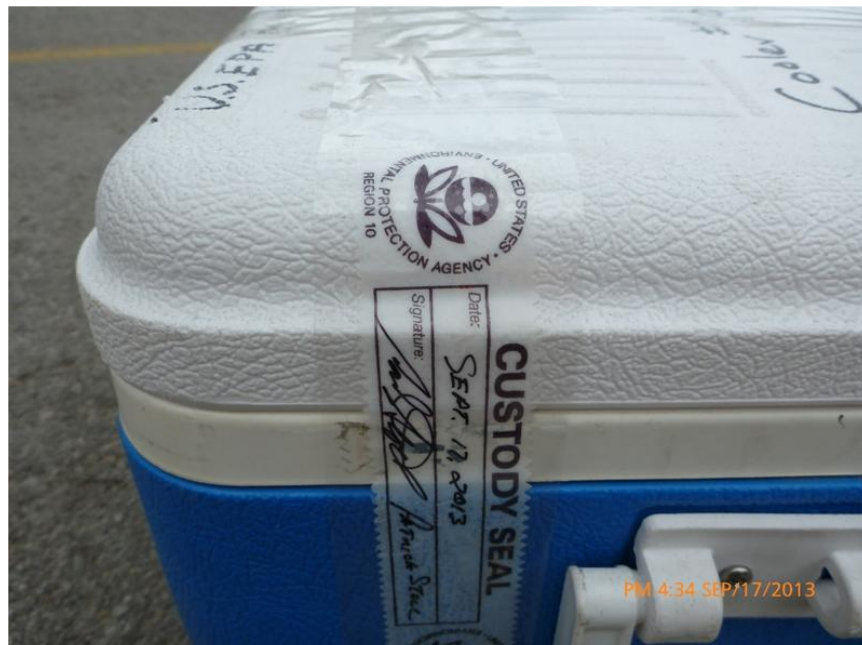
Photo No. 21 (P1000199)

The cooler with samples was sealed with strapping and evidence tape (Custody Seal) prior to delivery to UPS.
